52/OFFER/2021

Producer	Mercedes Benz - VAN
Model	519 CDI 190 KM
Specification	Stock vehicle
Transmission	Automatic
External lights	Original LED Performance
VIN	WDB9076571P181846
Number of passengers	19+1+1

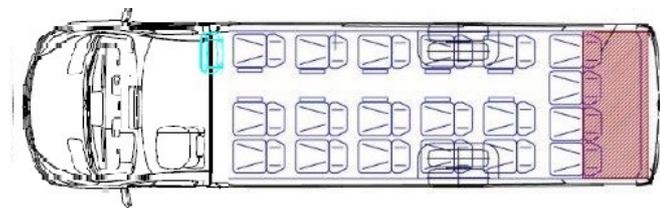
Attachment 1 - Seats - Scheme

- **Lighting**
- Ceiling
- Above and under windows - LED standard - Colour - white
- Seat platforms - LED standard - blue
- **Audio**
- Additional speakers - Roof speakers
- Radio - 2 Din
- TV
 - Type - Manual
 - Quantity - 1x
 - Size - 17"
- Microphone
- **Heating** - Convecter heating
- **Seats**
- Scheme (Attachment 1)
- Seat coustion - 45
- Features of the seat
